Discussion of Onsite-Insight Report for Ottoson Middle School

Capital Needs Assessment

Arlington, MA

April 29, 2022

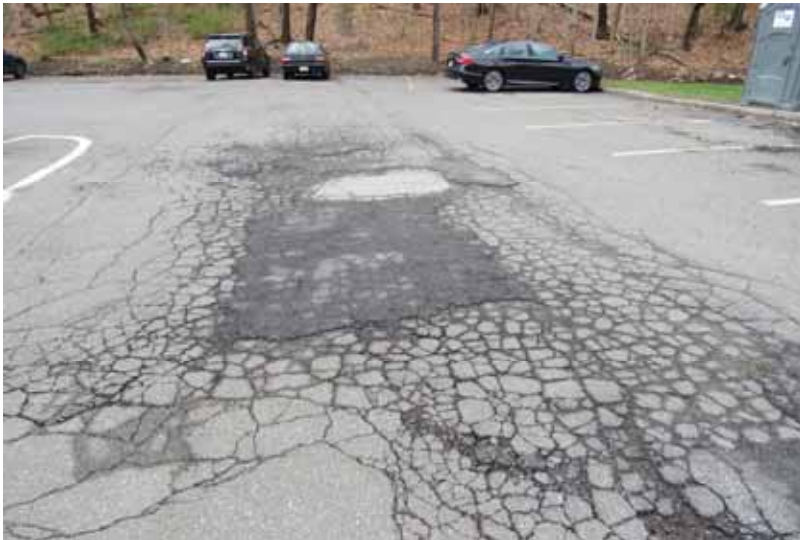
- 1. Costs for the development's site related elements total \$899,219 or \$5.29 per gross square feet in inflated dollars.**
2. The asphalt pavement appears to date to the 1997 rehabilitation. Deterioration in the form of cracking, depressions, and evidence of fatigue was observed within the asphalt. Costs to scarify and resurface the asphalt pavement are shown in Year 1. Future costs to carry out preventative maintenance repairs in the form of crack filling, sealcoating, and restriping are shown every five years starting in Year 6.

View of widespread pattern cracking and evidence of fatigue within asphalt-paved surface parking area as seen at rear of development

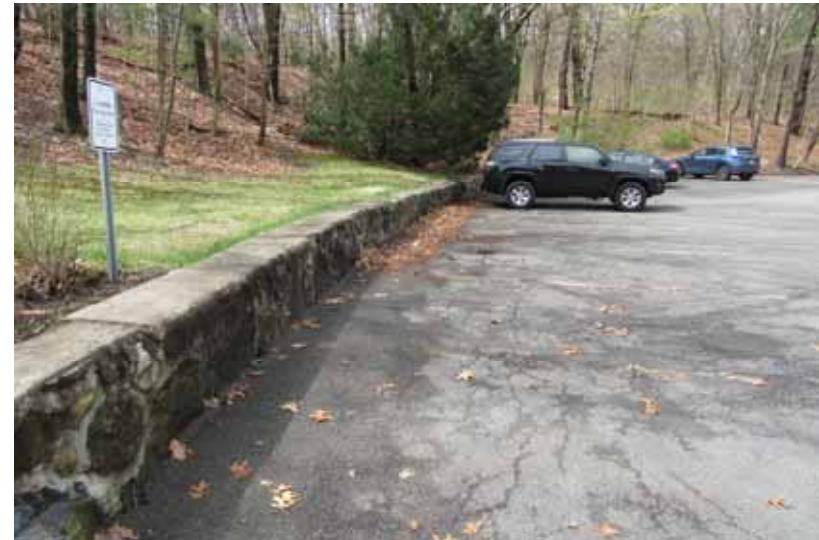
Additional view of pattern cracking and evidence of fatigue within asphalt pavement

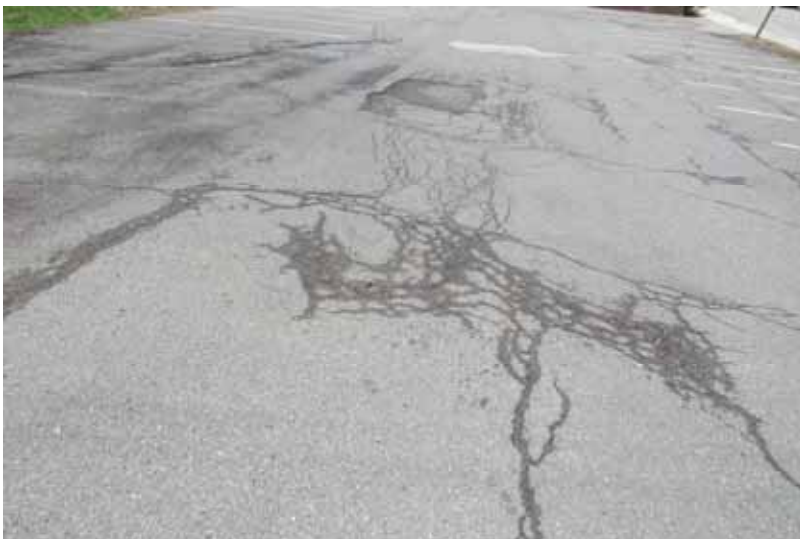
View of northeast corner lower asphalt parking lot – note similar deterioration/age related wear

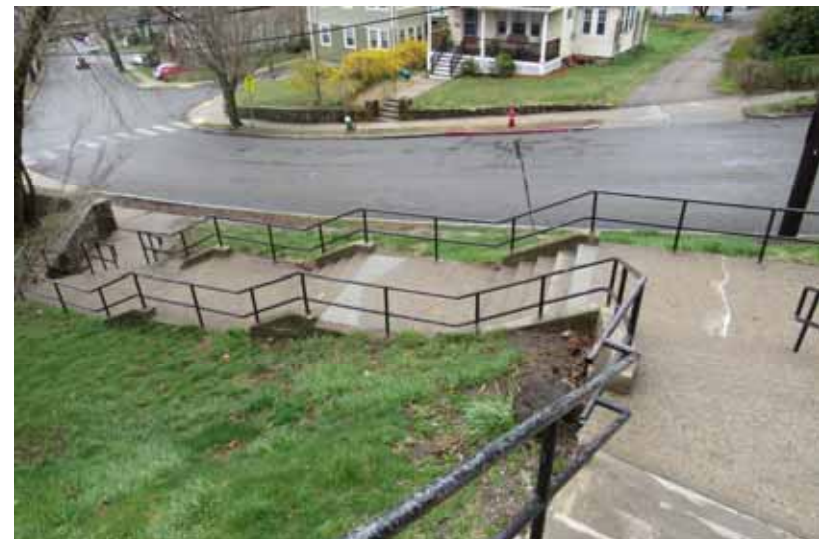
3. The concrete walkways, site steps, and landings vary in condition. Management reports concrete step replacement was carried out in recent years. Localized cracking and concrete spalls were observed within the steps, landings, and walkways. Periodic costs to carry out sectional concrete repairs/replacement (including as-needed refurbishment of metal railings/guardrails) are shown every eight years starting in Year 1.

View of east end concrete site steps and metal railings – railings exhibit paint peeling/weathering

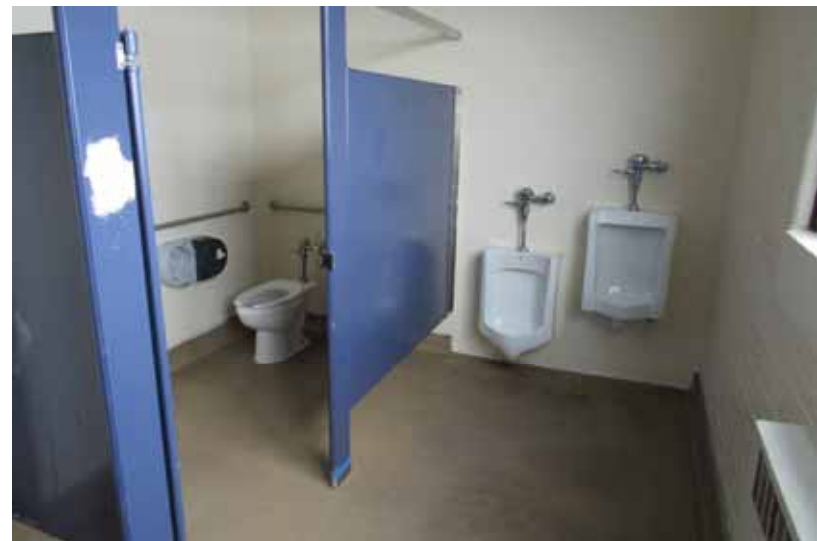
View of typical common restroom finishes and fixtures – age related wear

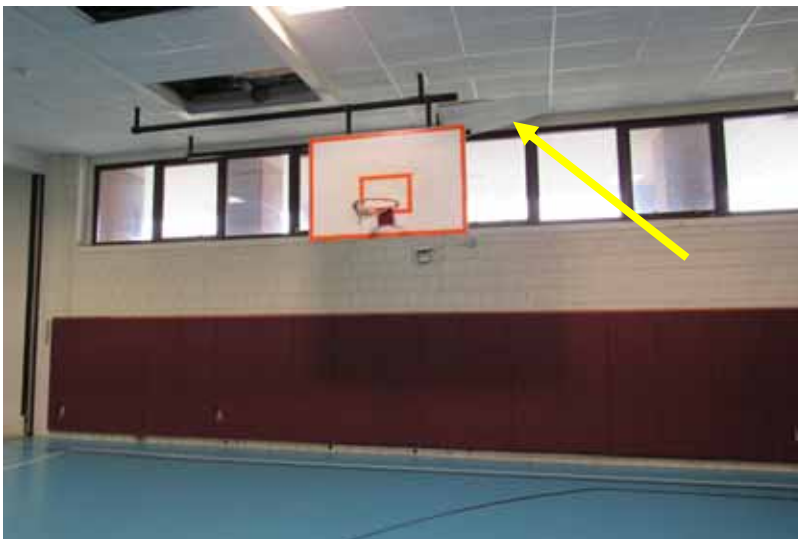
48. The building contains two gymnasiums, one gymnasium contains wood flooring and the second gym contains rubberized flooring (i.e., blue gym). Several displaced suspended ceiling tiles were noted within the blue gymnasium and pose a potential overhead risk. Replacement of the suspended ceiling tile including carrying out insulation improvements is shown in Year 1. Replacement of the rubberized flooring present within the blue gym is shown in Year 5. Costs to refinish the wood gymnasium flooring are shown in Years 1 and 11 (including replacement of wood stage flooring in Year 1). Periodic costs to carry out as-needed gymnasium/stage equipment replacement are shown every five years starting in Year 1.

View of blue gym finishes – note rubberized flooring – also note displaced suspended ceiling tiles and potential overhead risk
